# BUREAU OF SHIPS GROUP

## TECHNICAL INSPECTION REPORT

### U.S.S. PENNSYLVANIA (BB38)

#### TEST ABLE

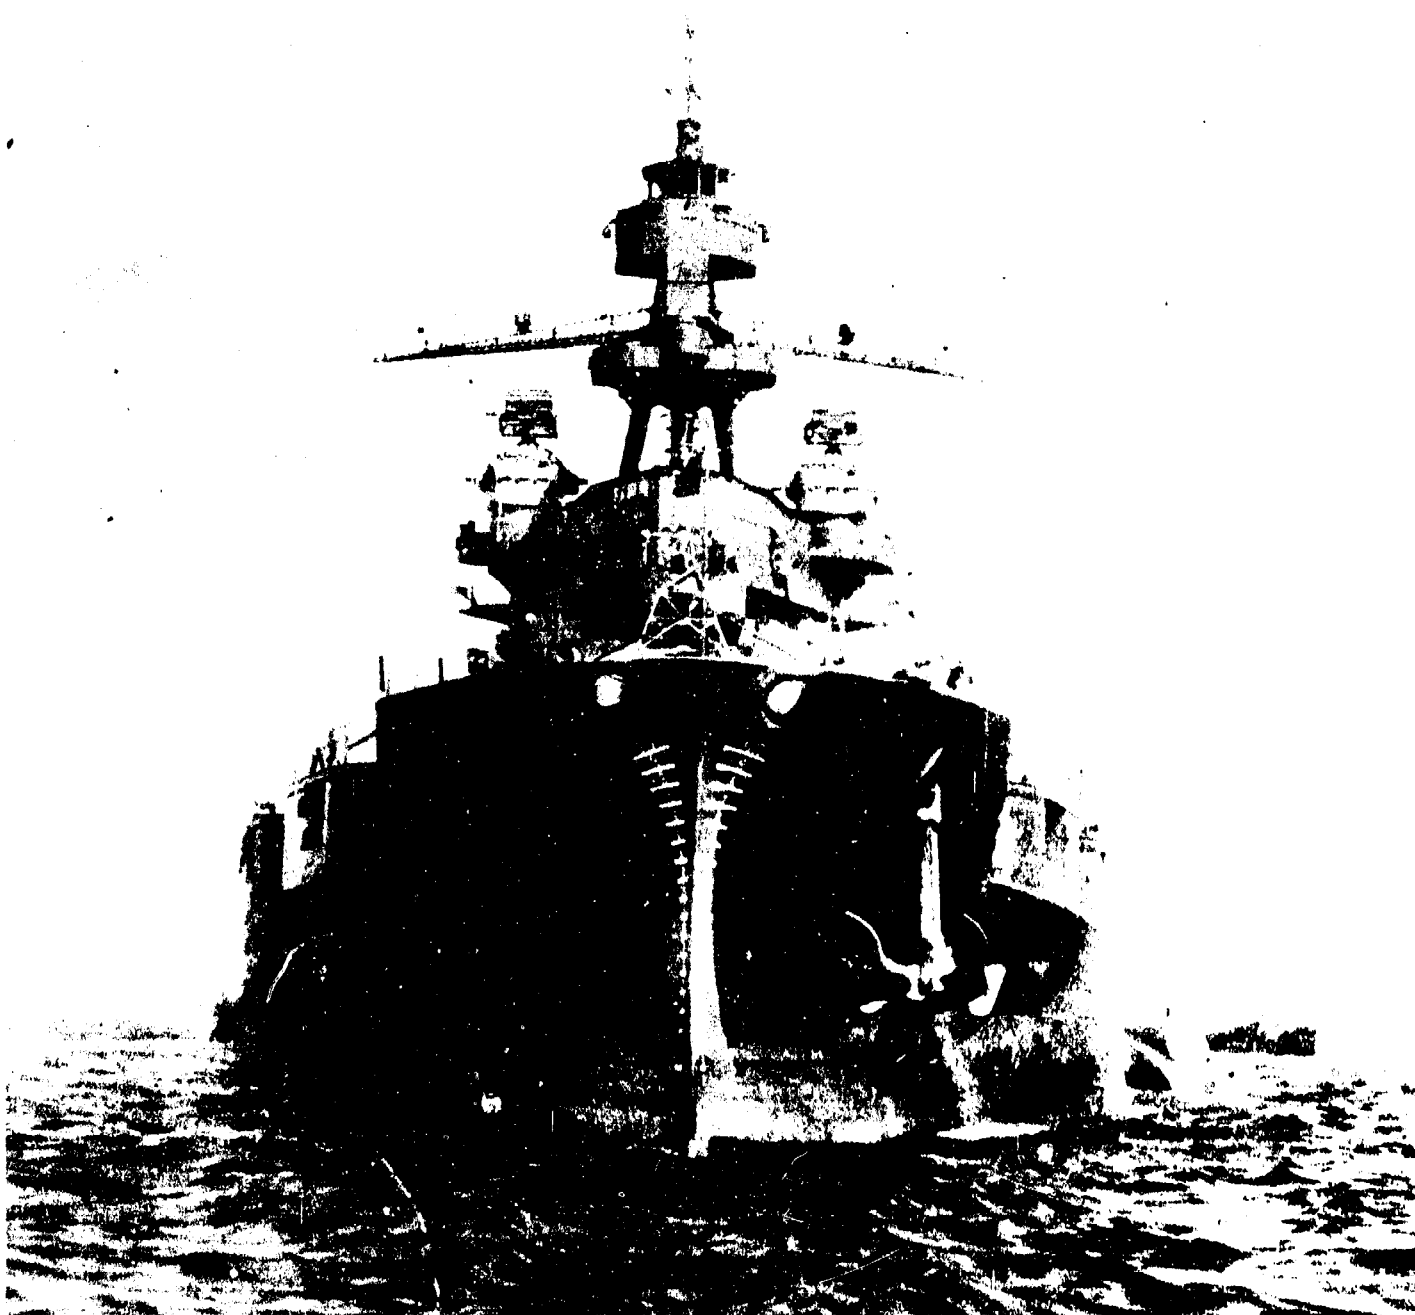
AA-CR-227-91-66. General view of bow from dead ahead after Test A.

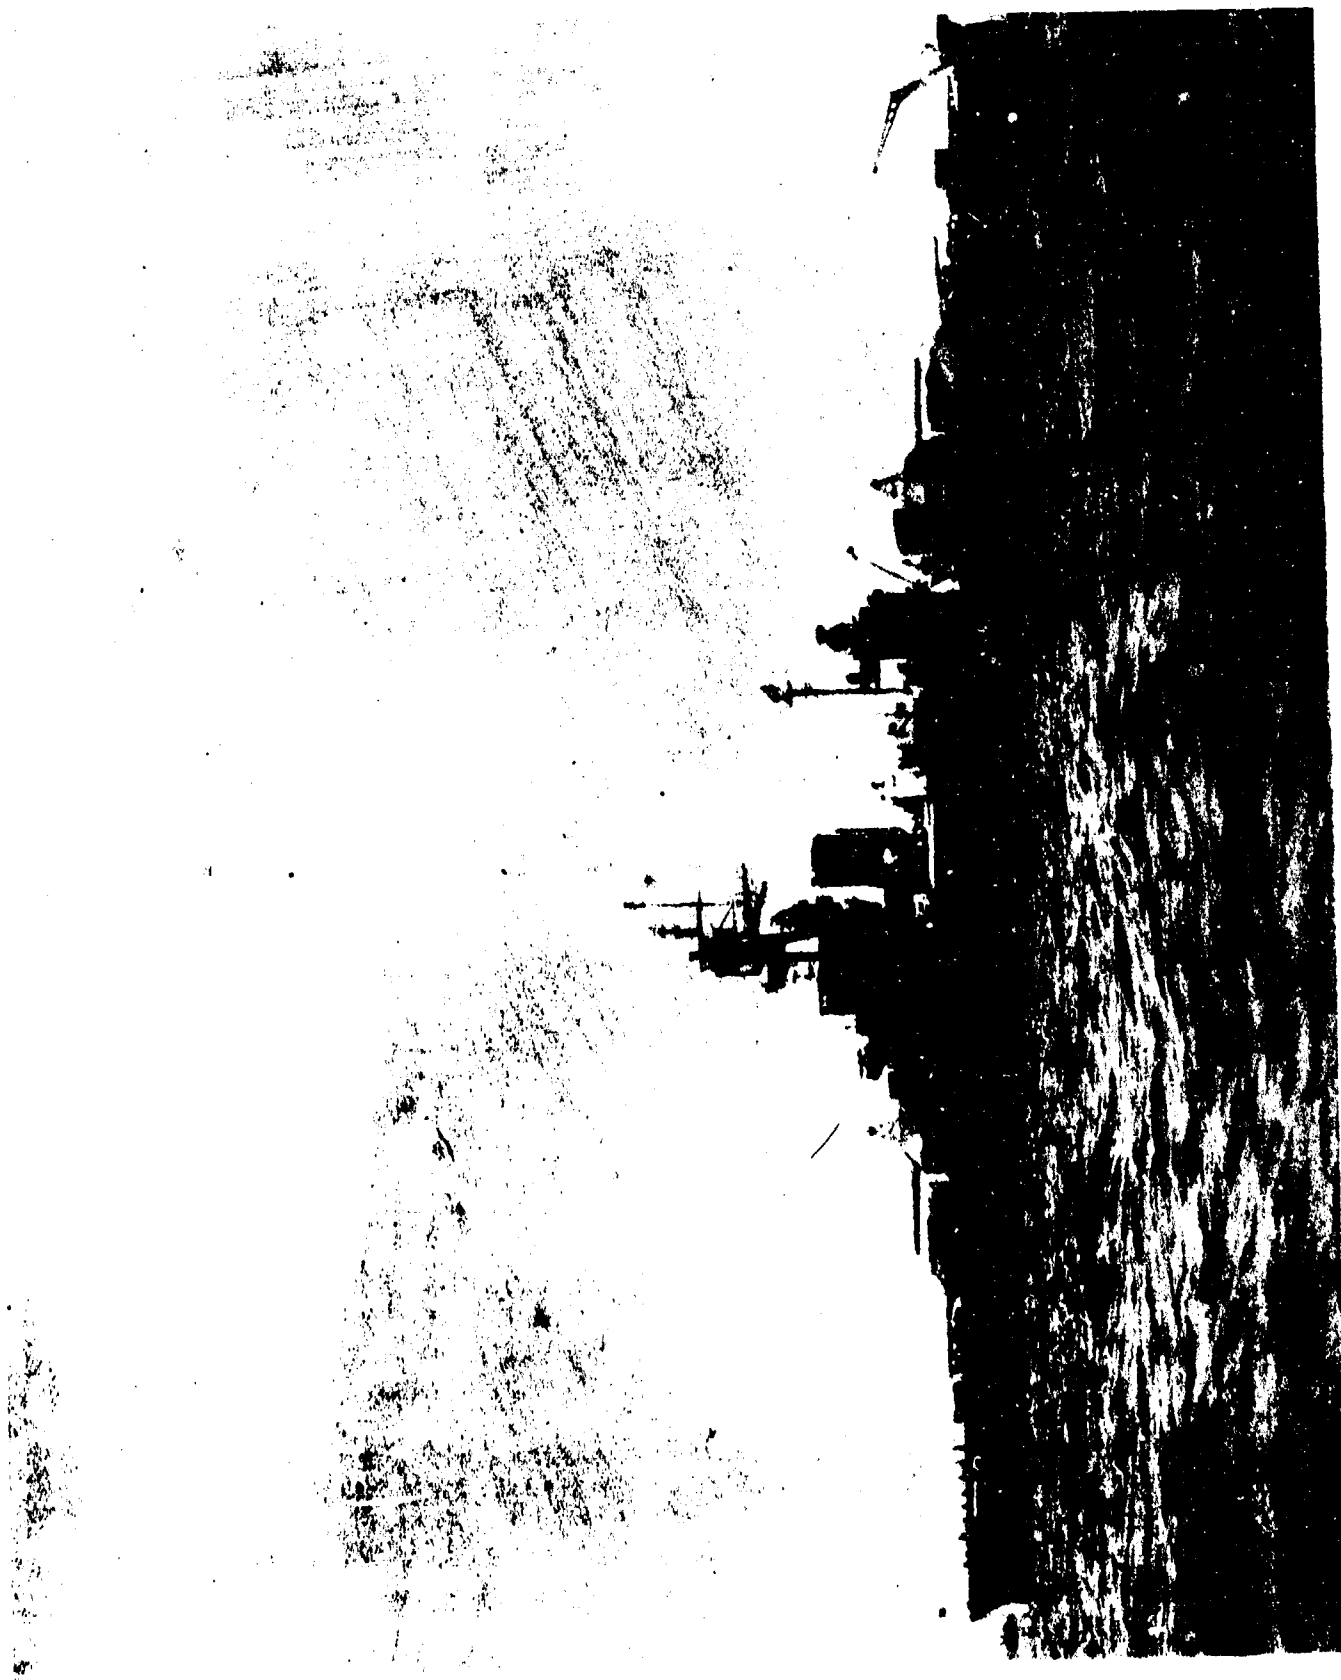
AA-CR-227-91-68. General view from off port beam after Test A.

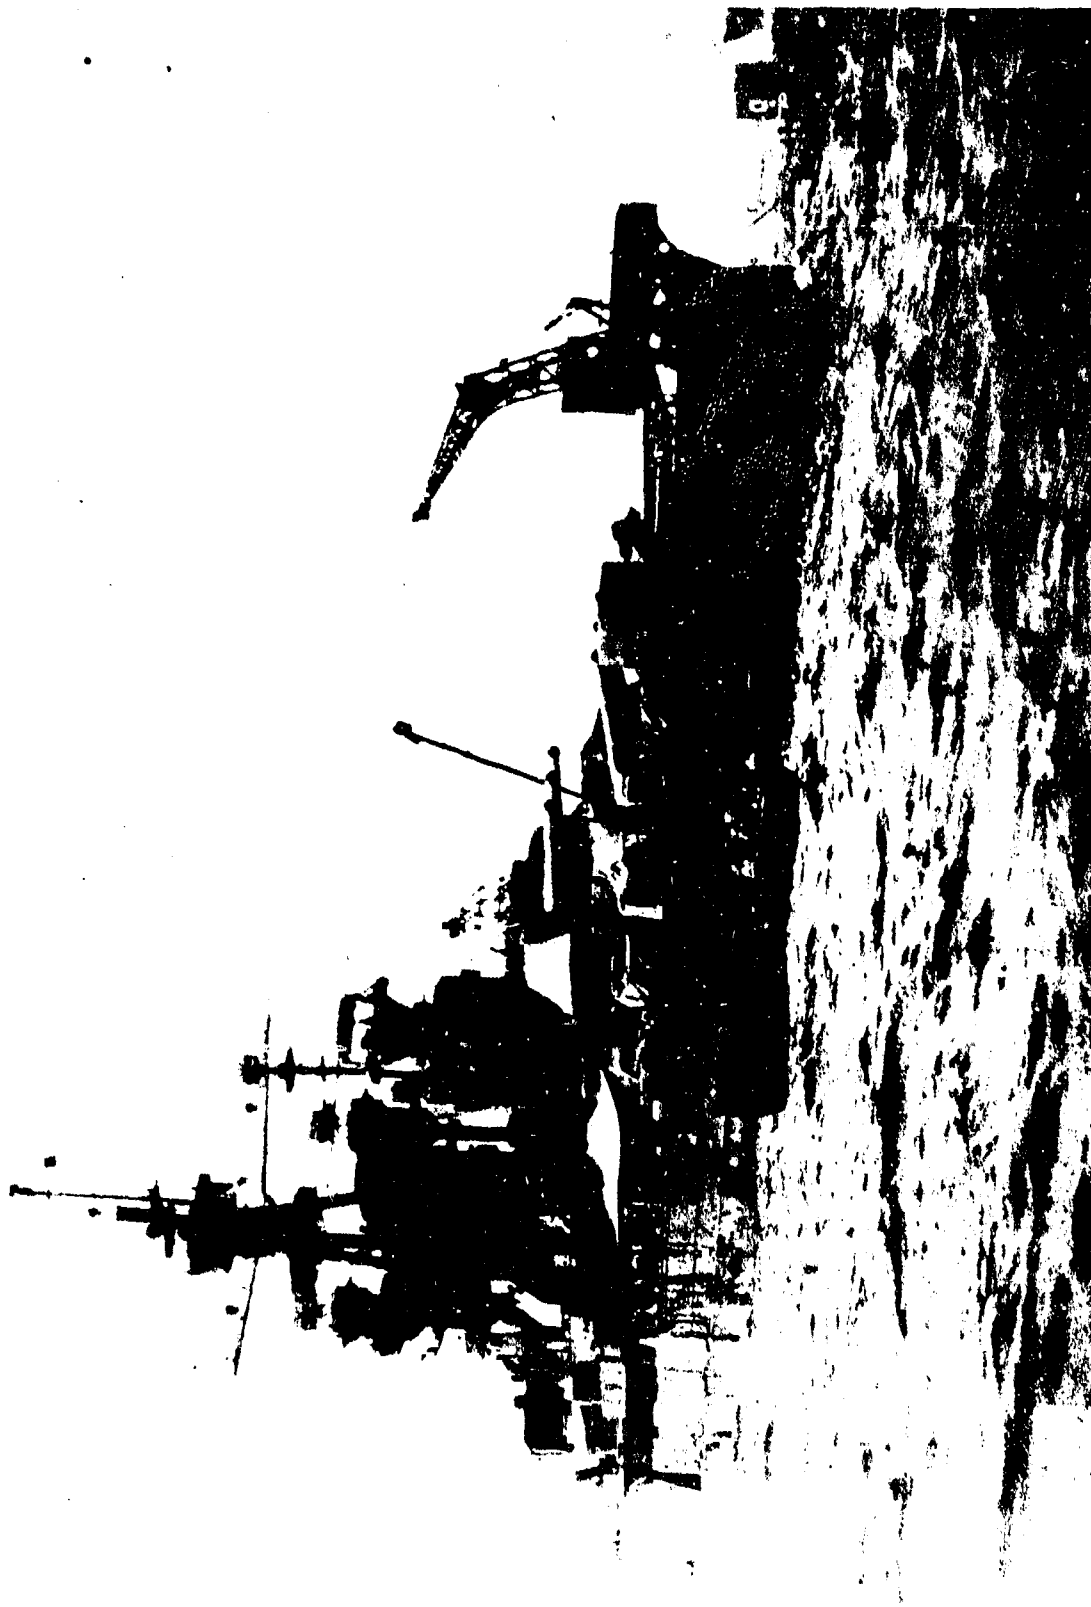
AA-CR-227-91-61. General view from off port quarter after Test A.

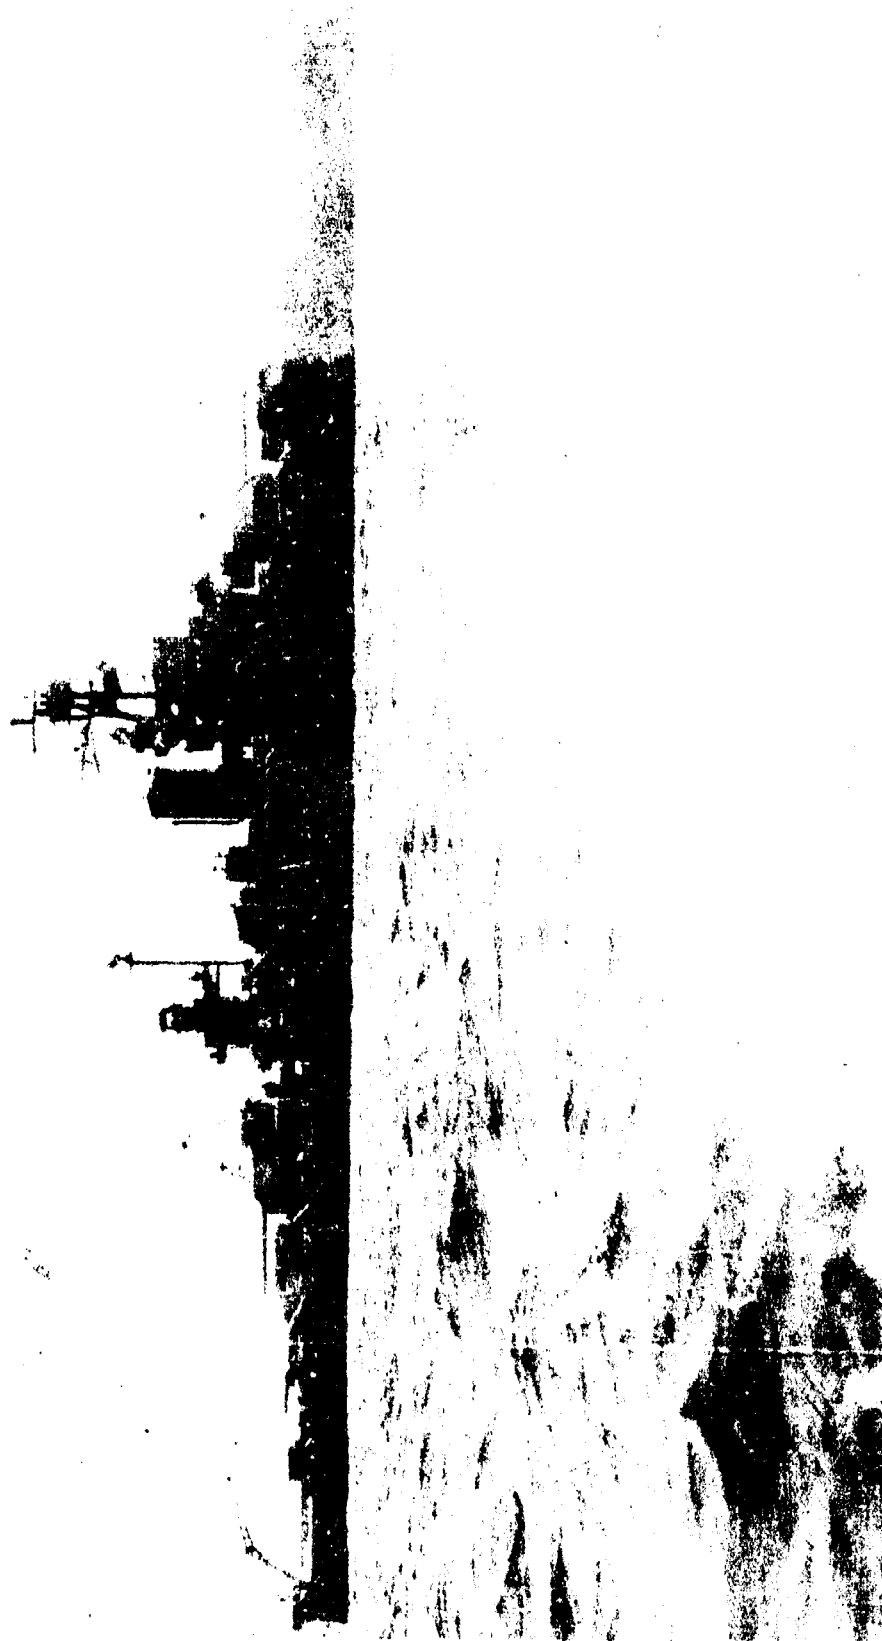
AA-CR-227-91-64. General view from off starboard beam after Test A.

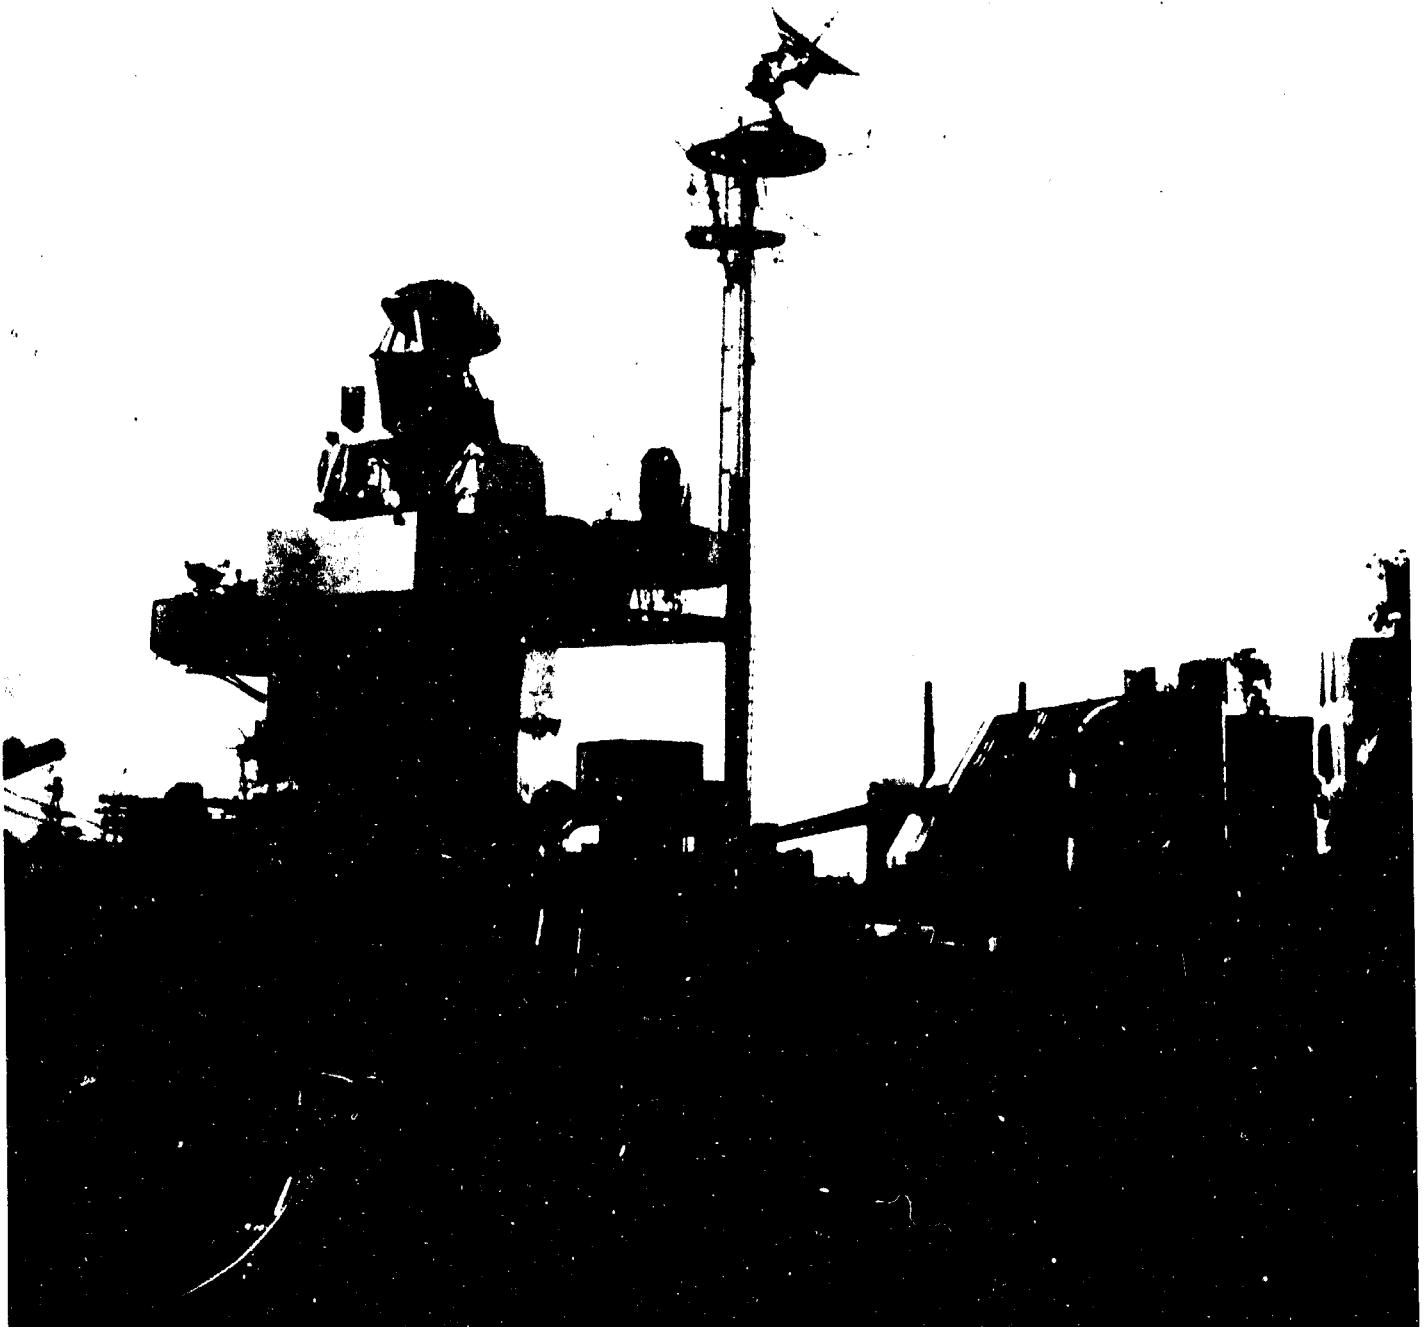
AA-CR-62-1831-3. Looking at mainmast area, frame 85, starboard side.

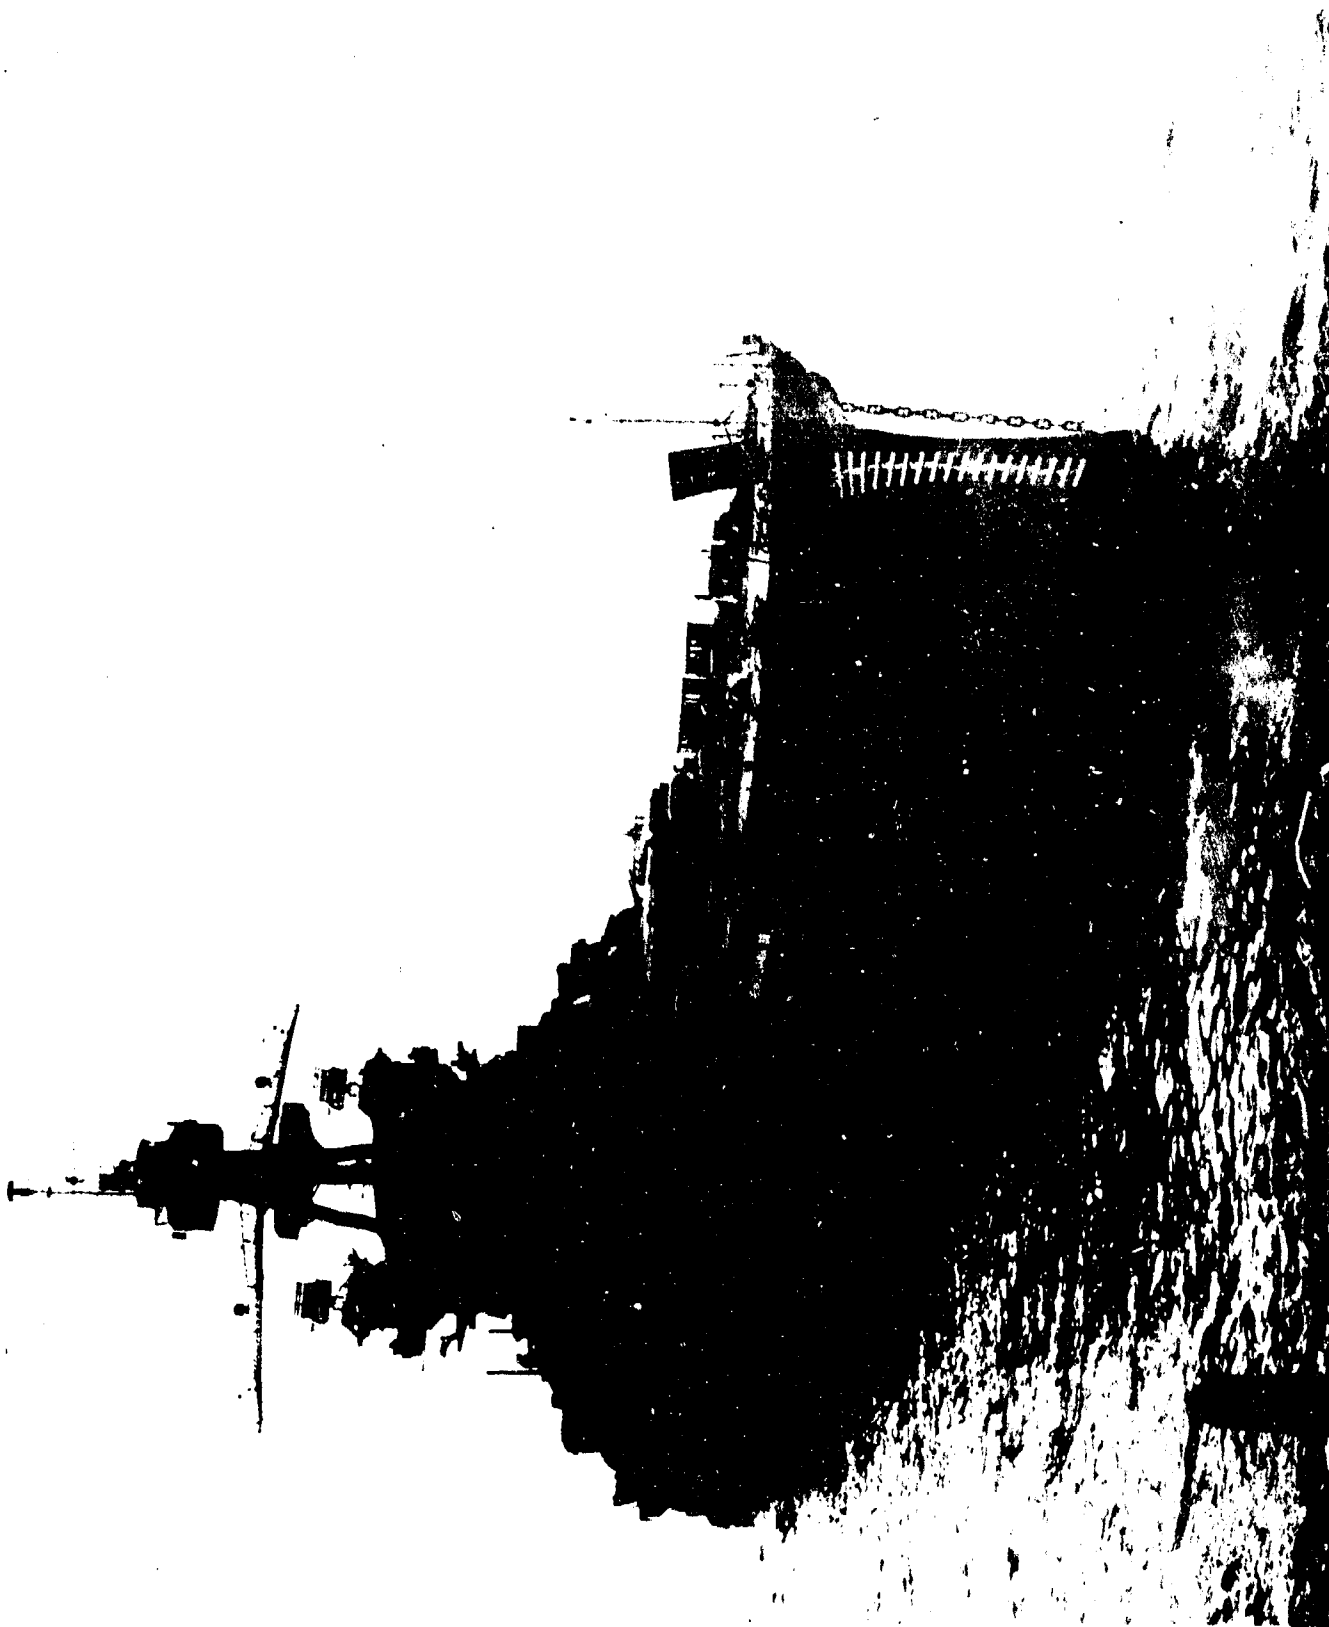
AA-CR-62-1831-1. General view from off starboard bow after Test A.
